Qualifications Analysis Main Street Market Place

Gardner, Kansas

August 23, 2018

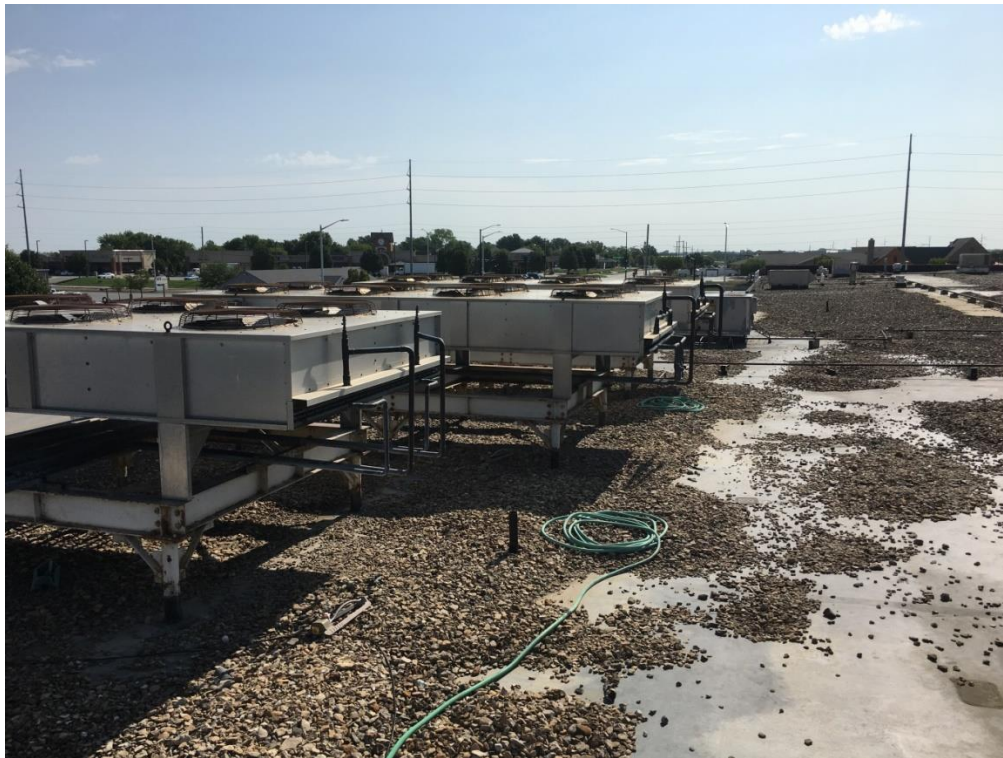
Photograph 2- Roof of 830 E Main Street, single-ply EPDM, rubber-based membranes with gravel top coat. While the age of the roof is unknown, there were many patches.

- Deteriorated building envelope systems (roof systems, flashing systems, windows and doors) which have become and are becoming compromised the roof of Price Chopper is nearing its end of life cycle. The retail building on Lot 4 while being a newer building has already replaced its original roof.

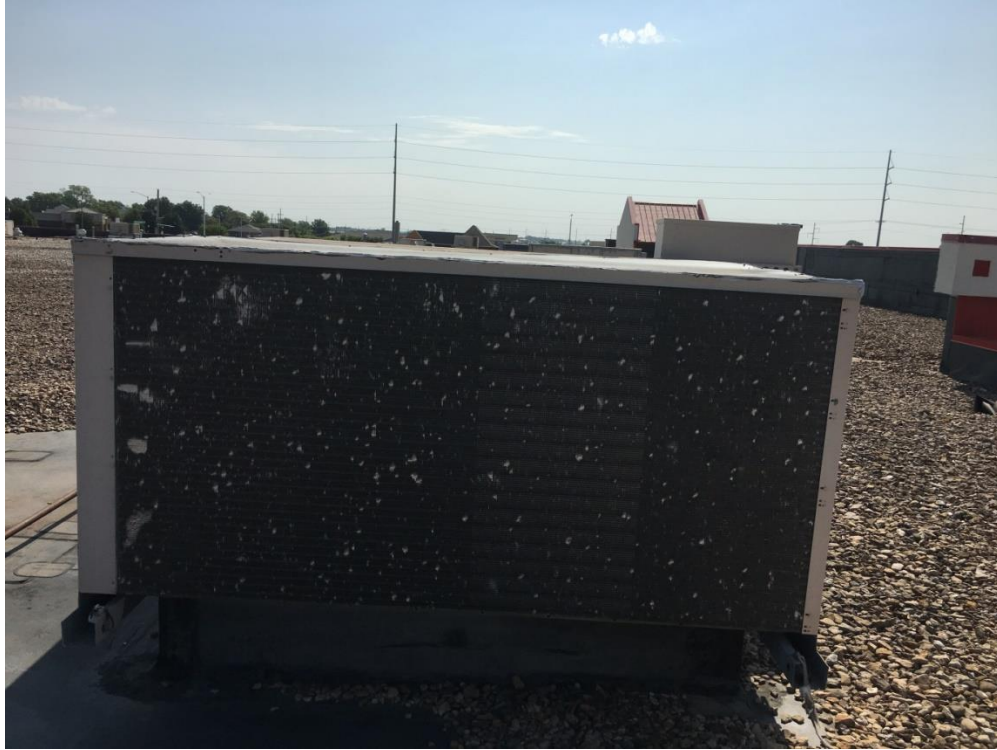
Photograph 3- Roof of 830 E Main Street, roof top units (RTU's) was manufactured in 1999 and is over 19 years old. The fins also show hail damage that can restrict airflow.

- Electrical systems. The building suffers from copper pipe electrolysis, which will be discussed later in the report.
- HVAC and refrigeration equipment within the Price Chopper is original equipment and while maintained is not efficient and are in need of replacement.

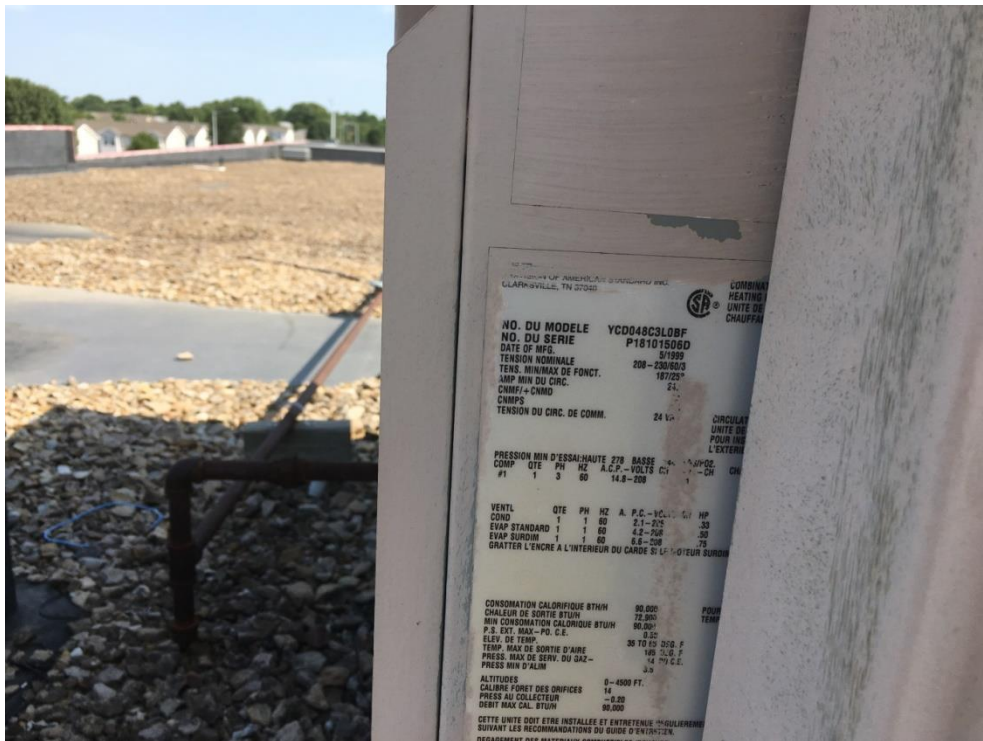
Photograph 4- 830 E Main Street, roof top units (RTU's) label shows they were manufactured in 1999 and are over 19 years old. The fins also show hail damage that can restrict airflow.

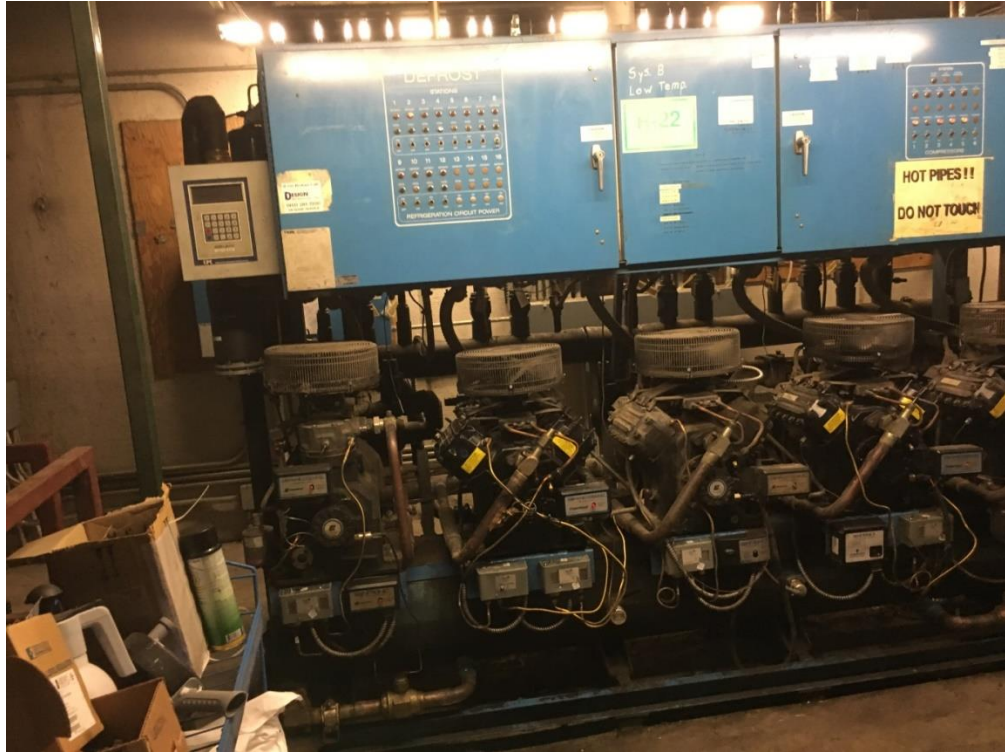
Photograph 5- Expensive infrastructure like refrigeration and HVAC are in place, and are at the end of their life expectancy, and not as efficient as modern equipment.

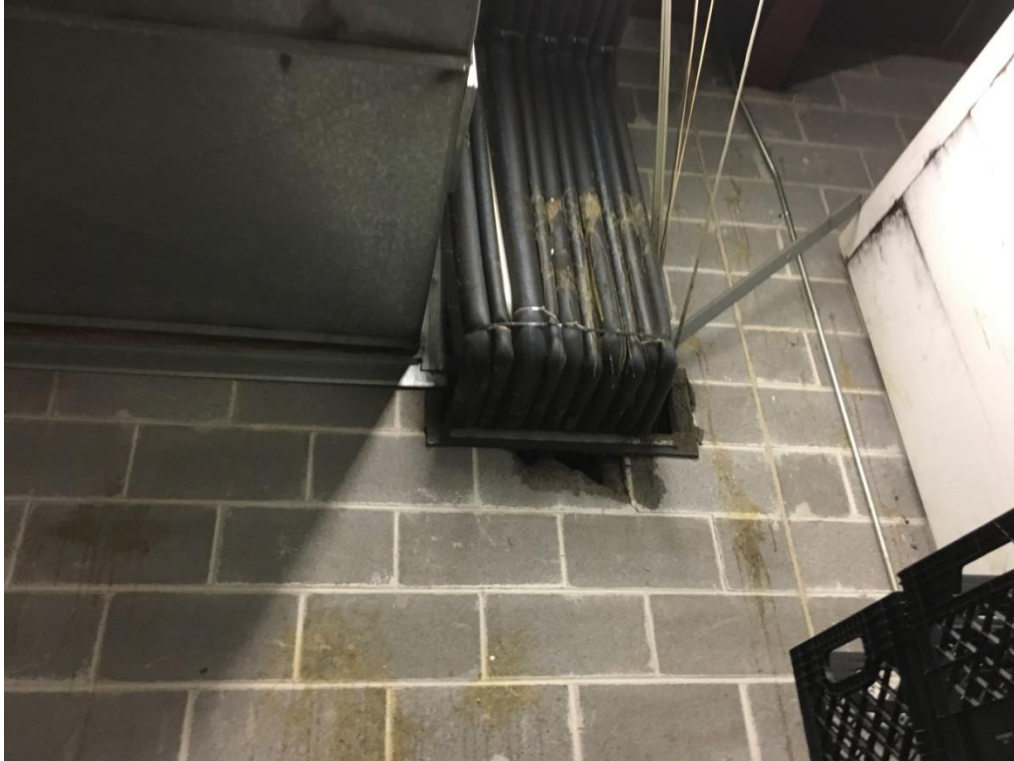
Photograph 7- Expensive infrastructure like refrigeration and HVAC are in place, and require more maintenance than modern equipment.

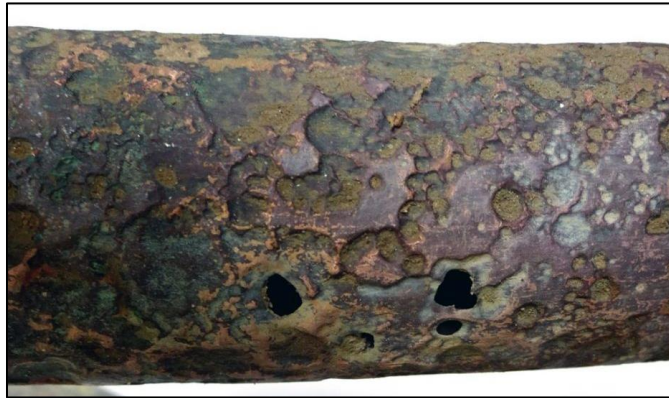
Photograph 8- Example of damage to copper (Image not taken within Redevelopment Area, example only).

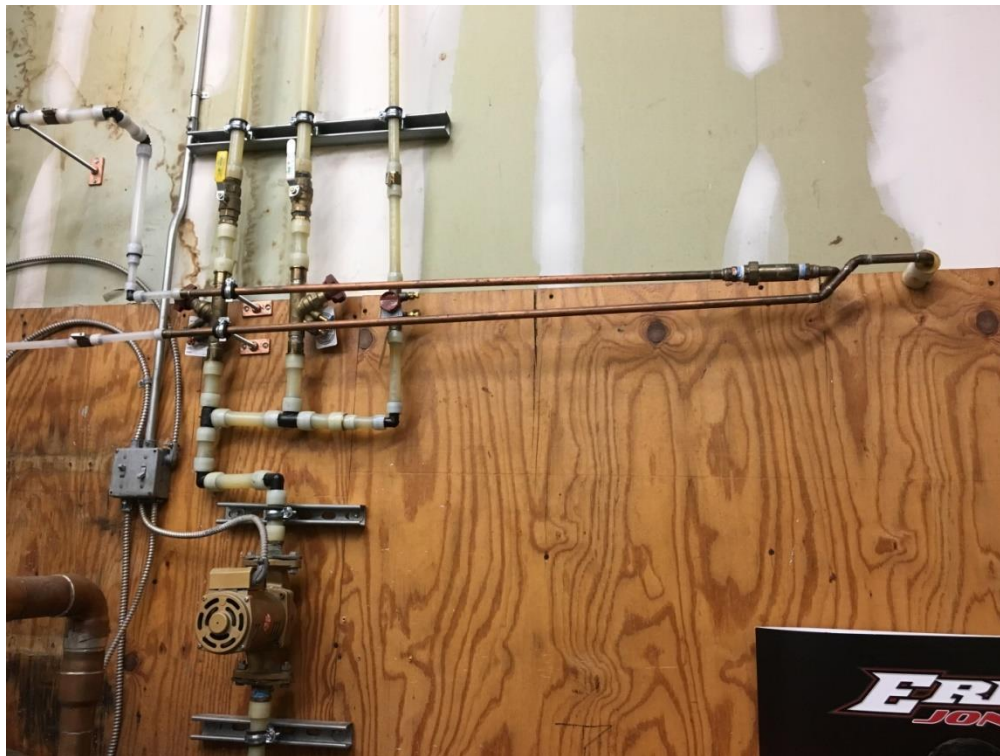
During the walk through, the property manager indicated that the building has suffered from a condition called copper pipe electrolysis. This condition has caused expensive repairs and the issue is still present. Below is an excerpt from a plumbing expert that explains the condition, “Copper Pipe Electrolysis” July 11, 2016 in Opinion & Expertise by David Balkan:

Photograph 9- Repairs to plumbing system from copper pipe electrolysis condition.

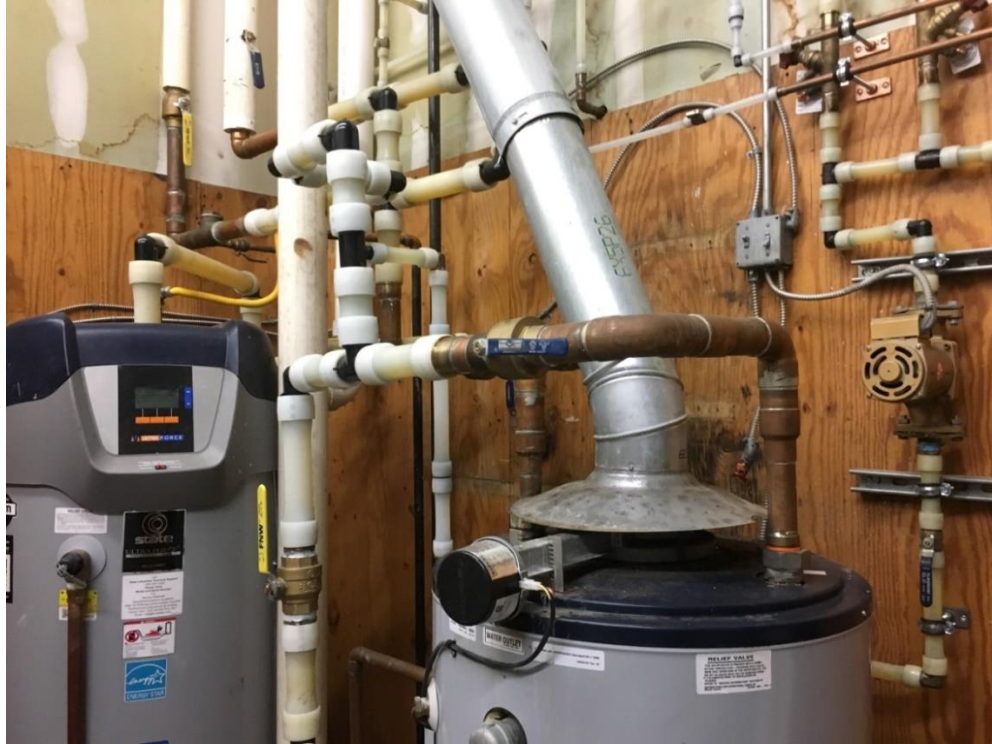
Photograph 10- Repairs to plumbing system from copper pipe electrolysis condition.

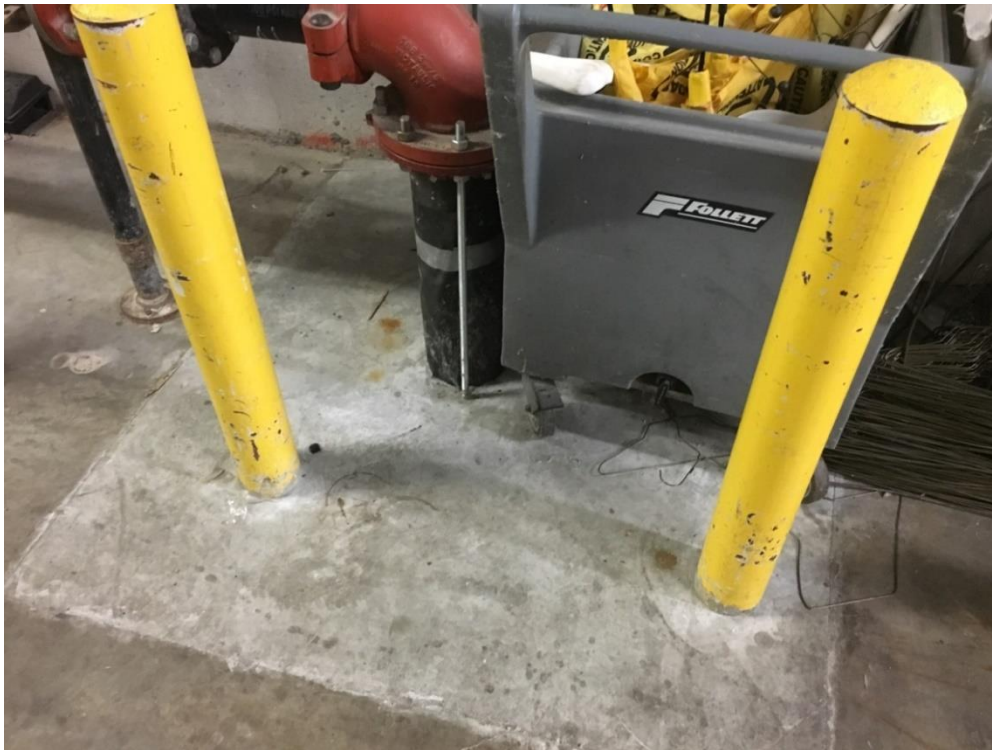
Photograph 11- Repairs to plumbing system from copper pipe electrolysis condition, the main water line was deteriorated.

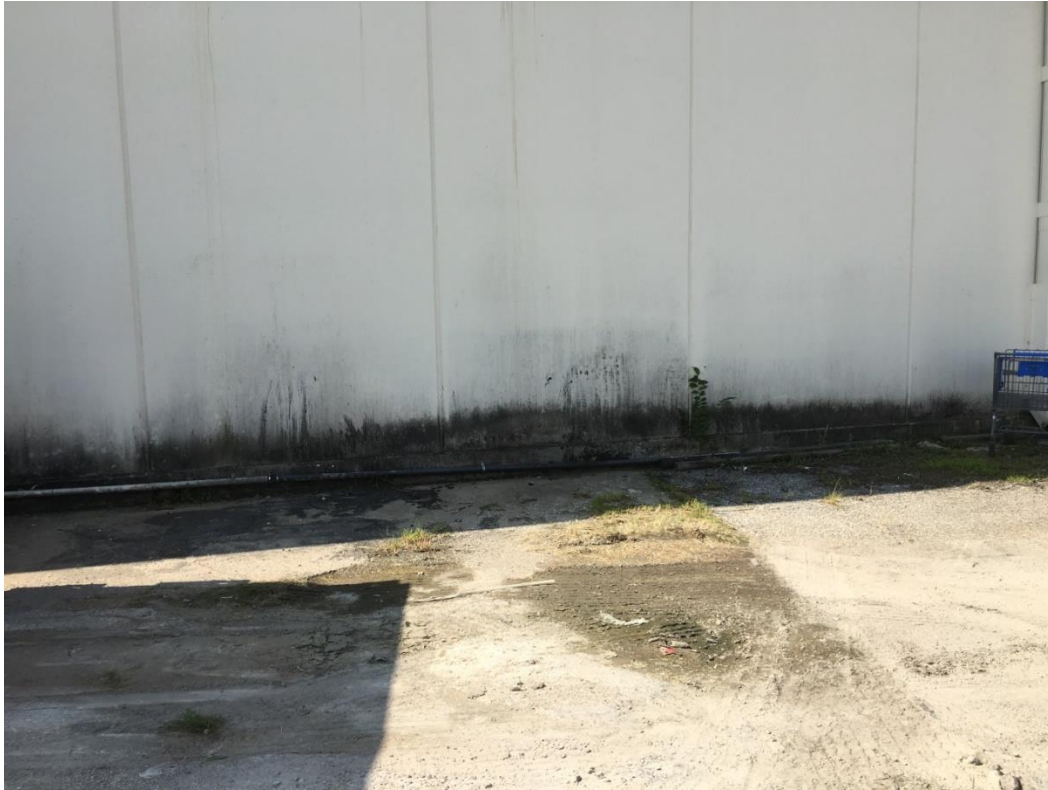
Photograph 12- Lot 5- building façade deterioration in rear dock loading area.

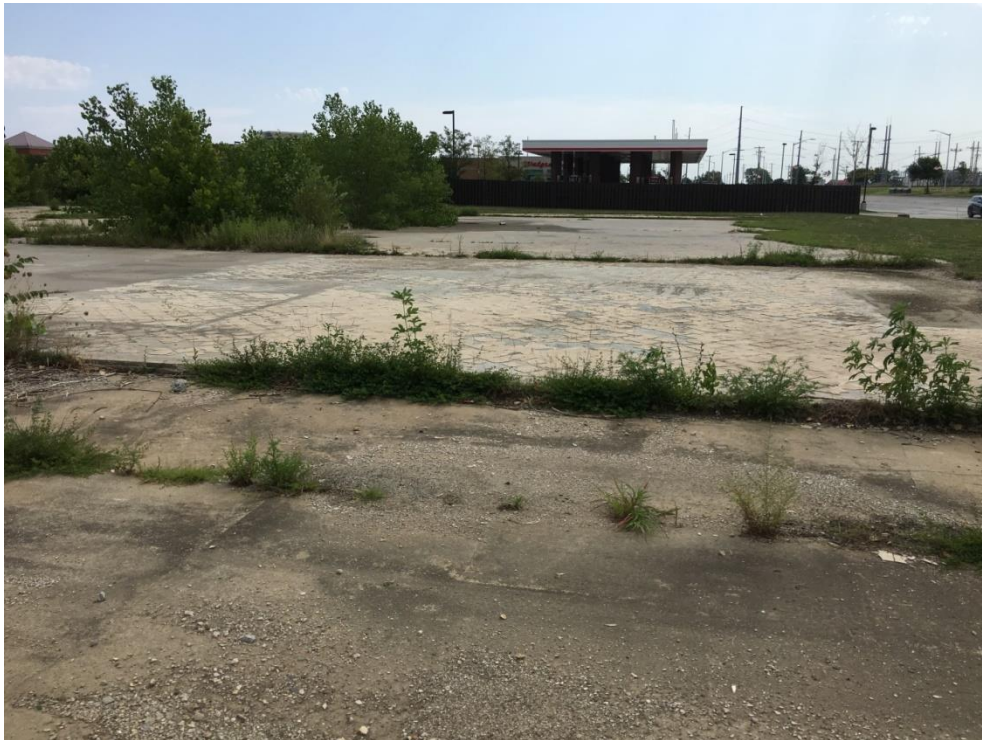
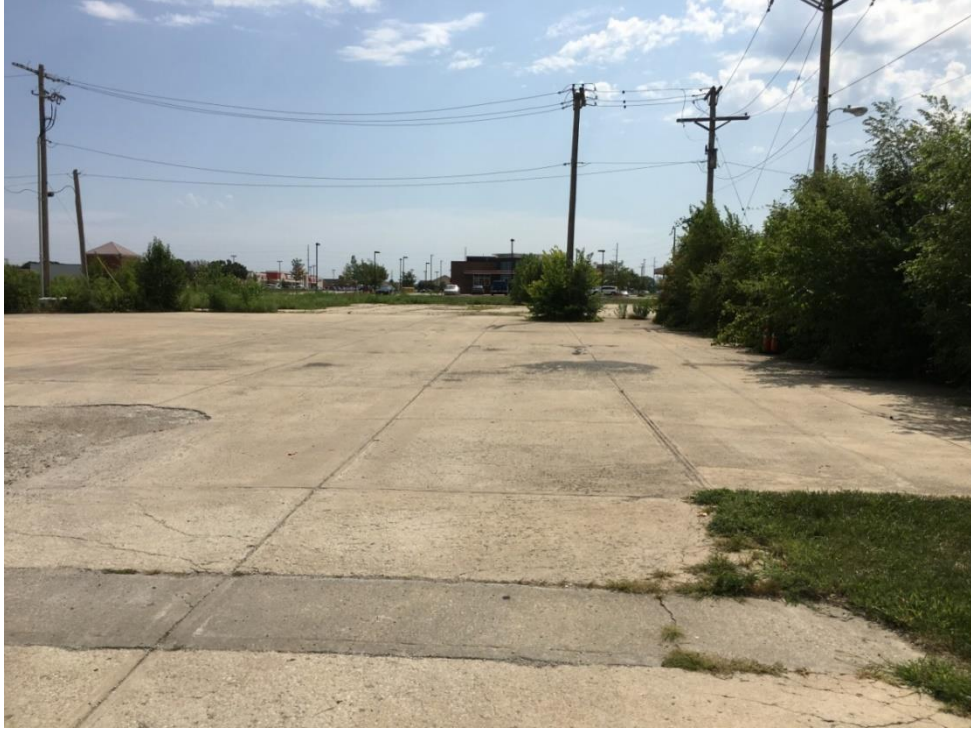
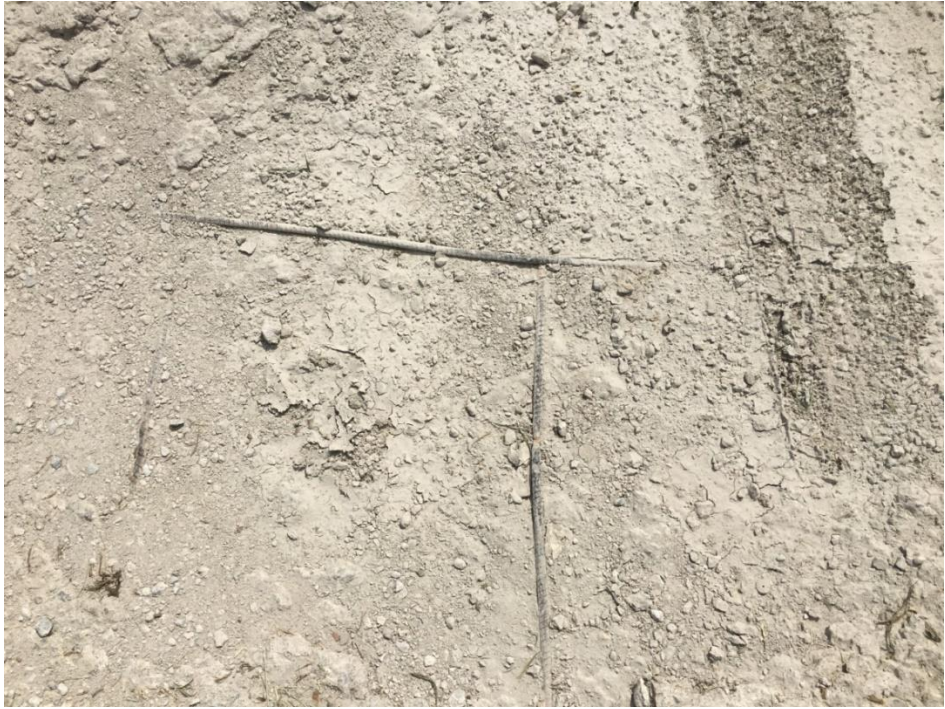
The two buildings foundations shown on the aerial image from 2000 are seen in the below photographs and is clearly deterioration of site improvements within the Redevelopment District.

Photograph 13- Existing foundation of two buildings on Lot 2 of the Redevelopment District.

Photograph 14- Existing foundation of two buildings on Lot 2 of the Redevelopment District.

Photograph 15- Existing foundation of two buildings on Lot 2 of the Redevelopment District.

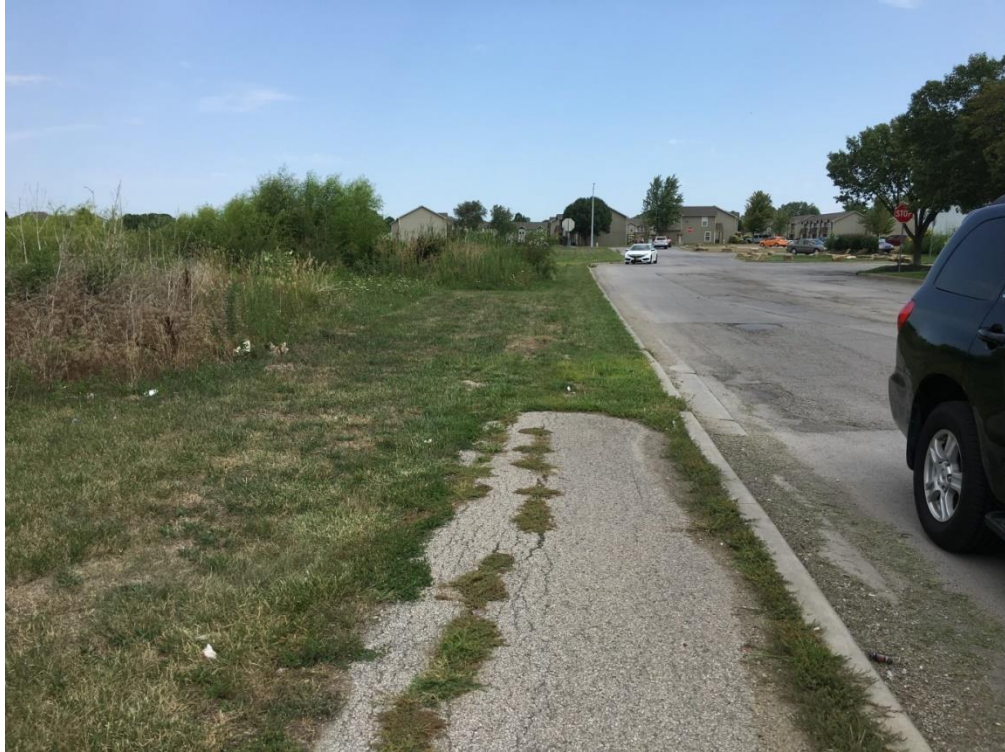
Photograph 17- North South Private Drive, connecting East Main Street to Lincoln Lane
Redevelopment District, shown inadequate or crumbling sidewalk.

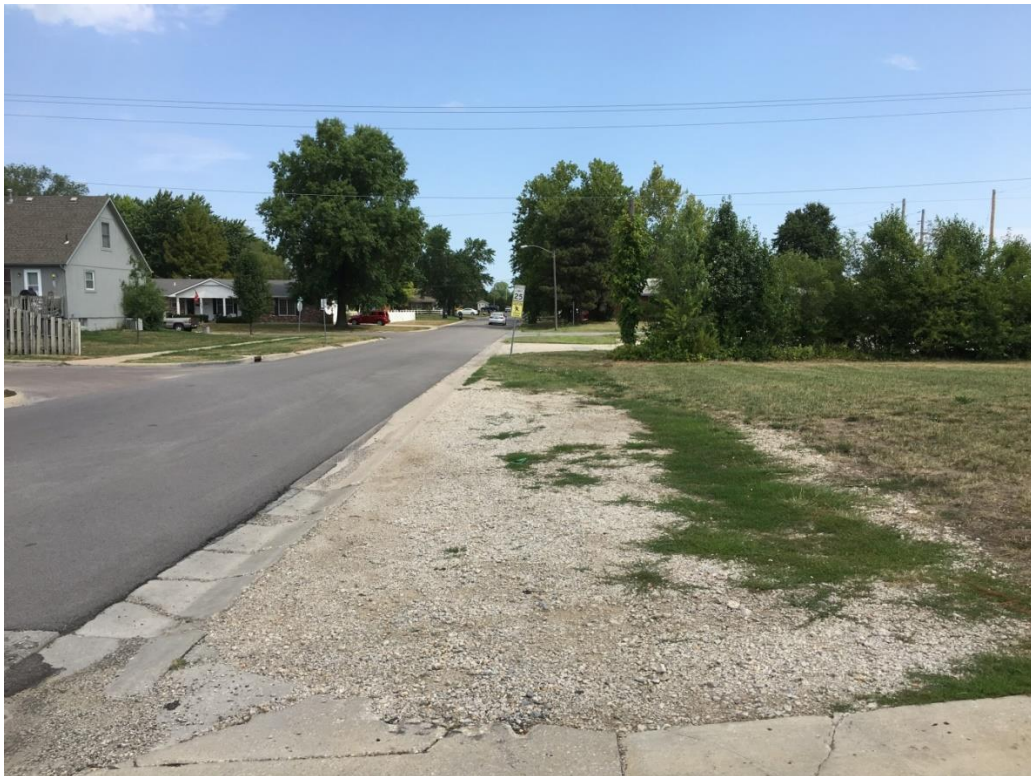
Photograph 18- Cedar Street Looking North, connecting East Main Street to Lincoln Lane
Redevelopment District, shown inadequate or crumbling sidewalk.

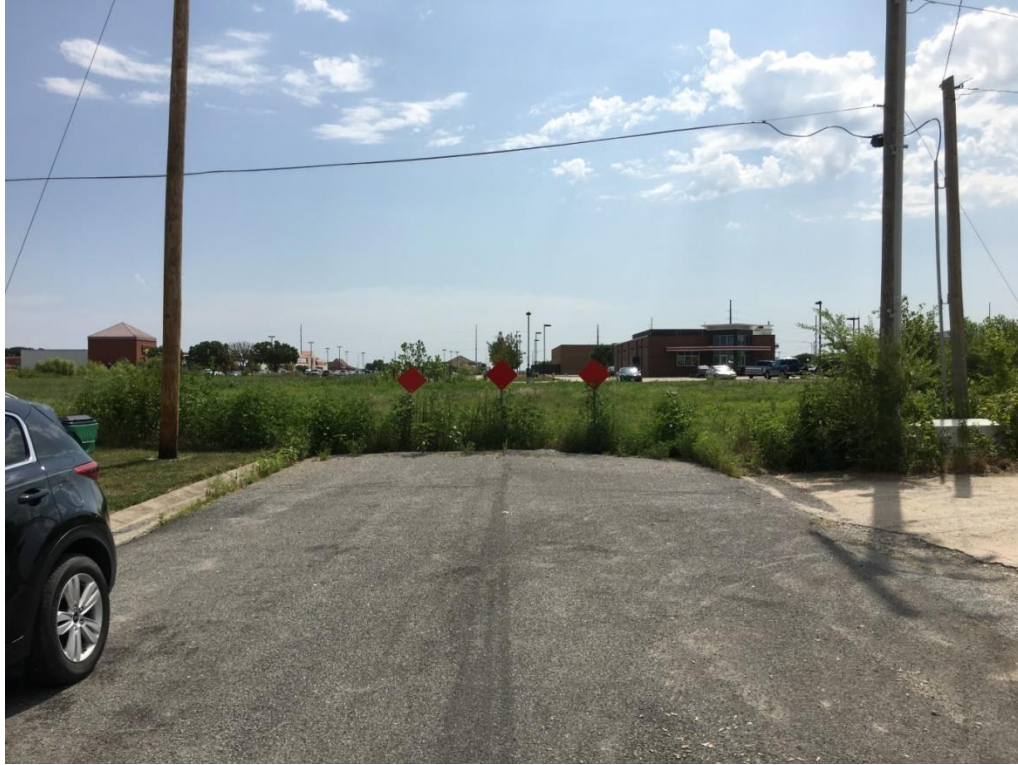
Photograph 19- Terminus of East Shawnee Street Looking East into the Redevelopment District, shown inadequate access.

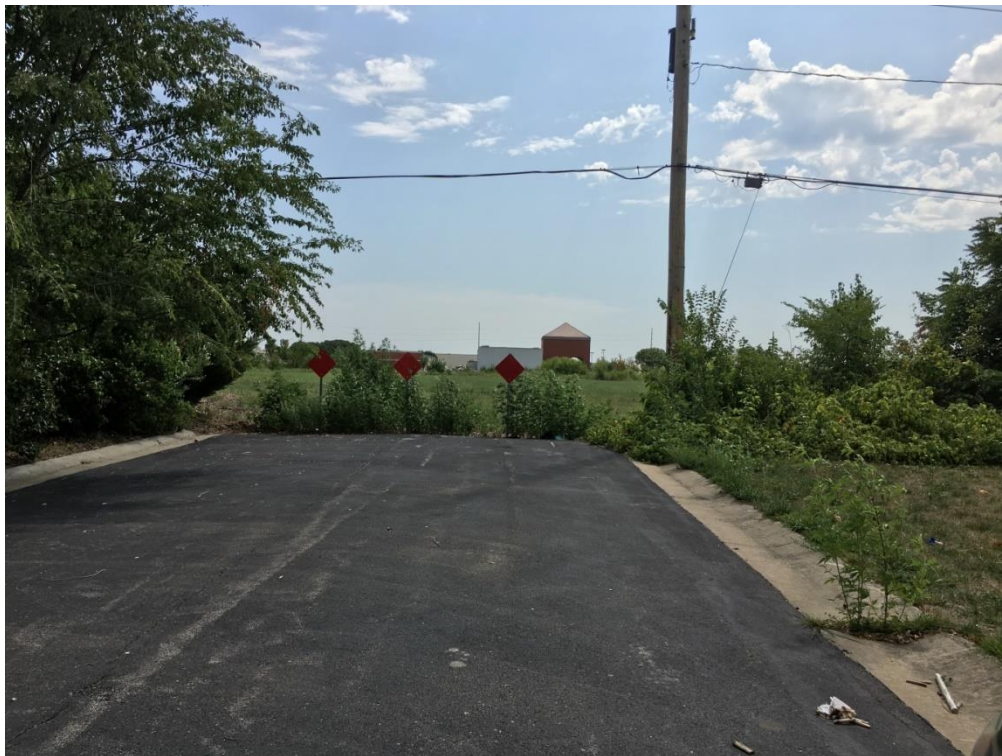
Photograph 20- Terminus of East Washington Street Looking East into the Redevelopment District, shown inadequate access.

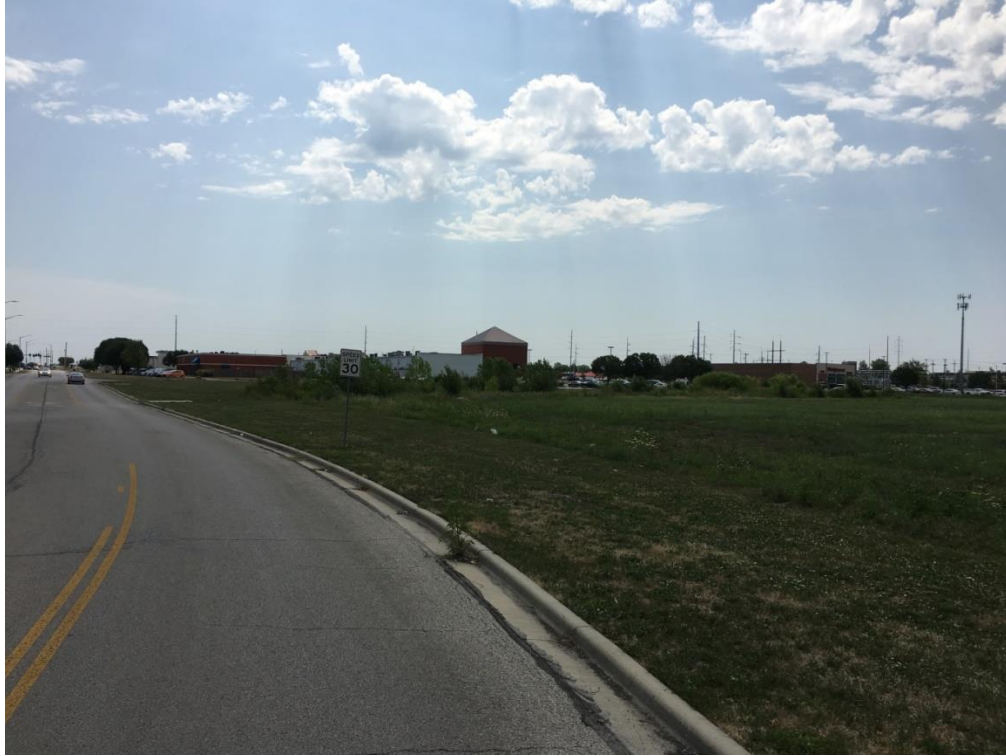
Photograph 21- Lincoln Lane Looking West into the Redevelopment District, shown inadequate access.

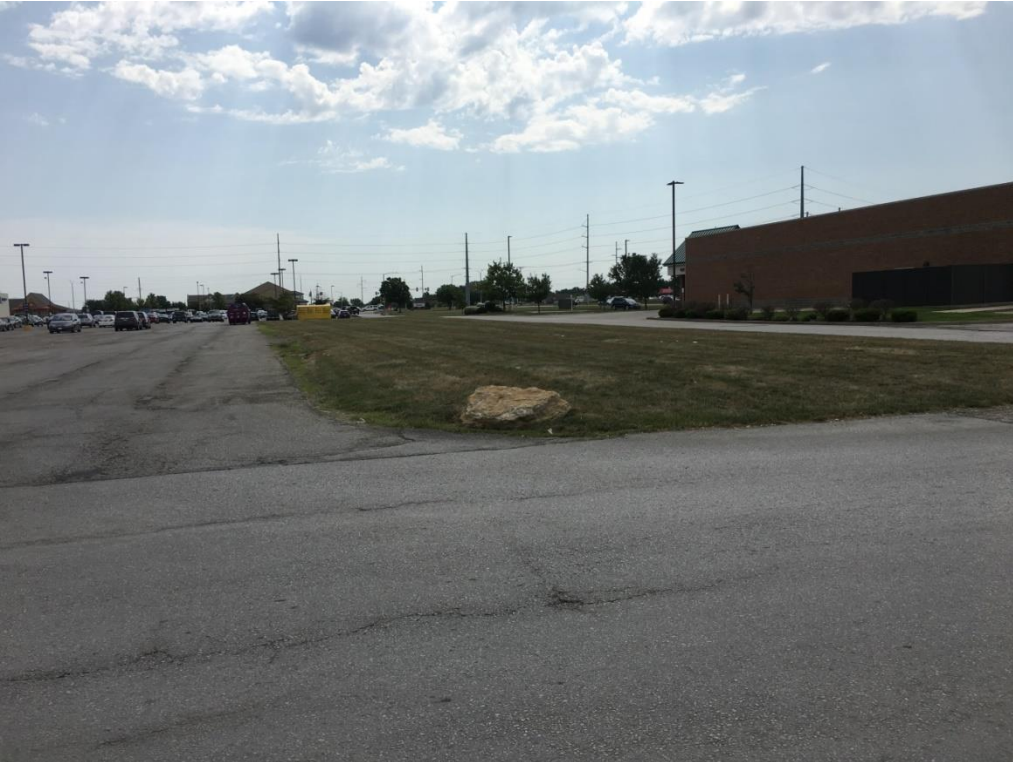
Photograph 22- Private Drive Looking East into the Redevelopment District, shown inadequate curbs and infrastructure.

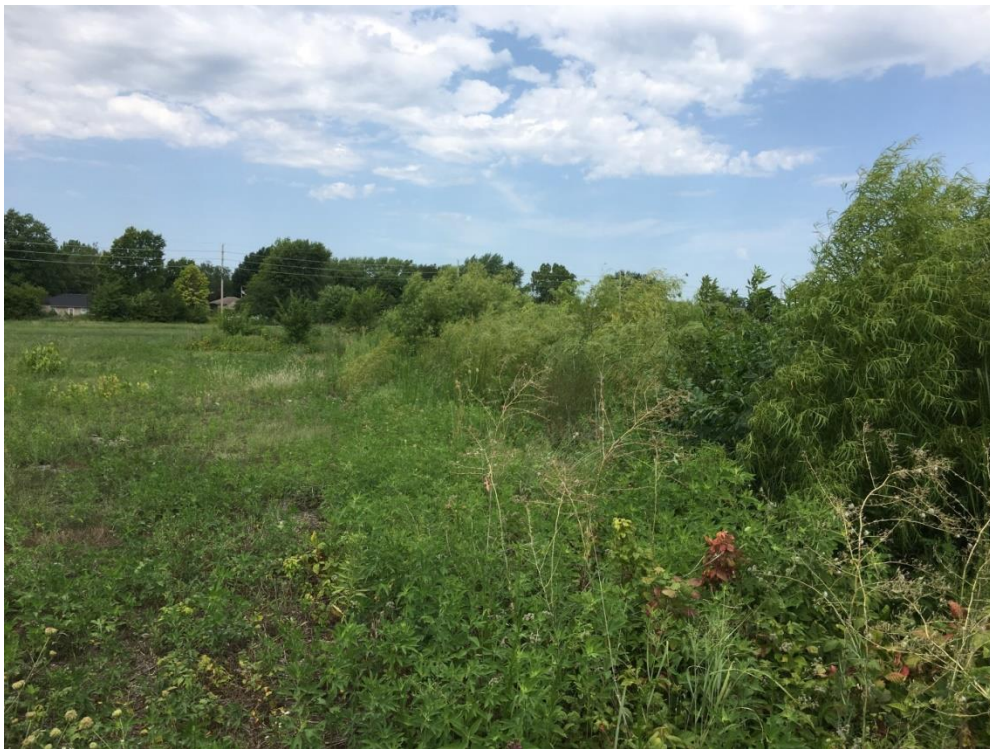
Unsafe Conditions: The ravine that is fed and eroded by the open stormwater channel that runs the length of the Redevelopment District could create unsafe conditions.

Photograph 24- Open Channel Drainage within Lot 1 or Redevelopment District.

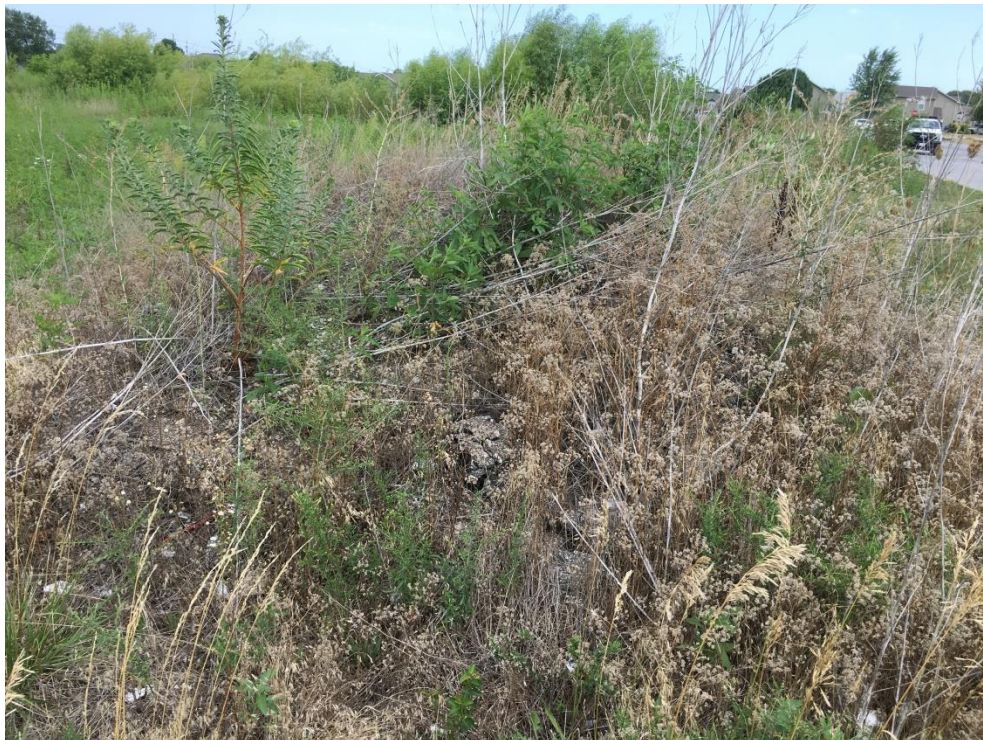
Photograph 25- Location middle of Lot 1, showing debris (asphalt) and rubble.

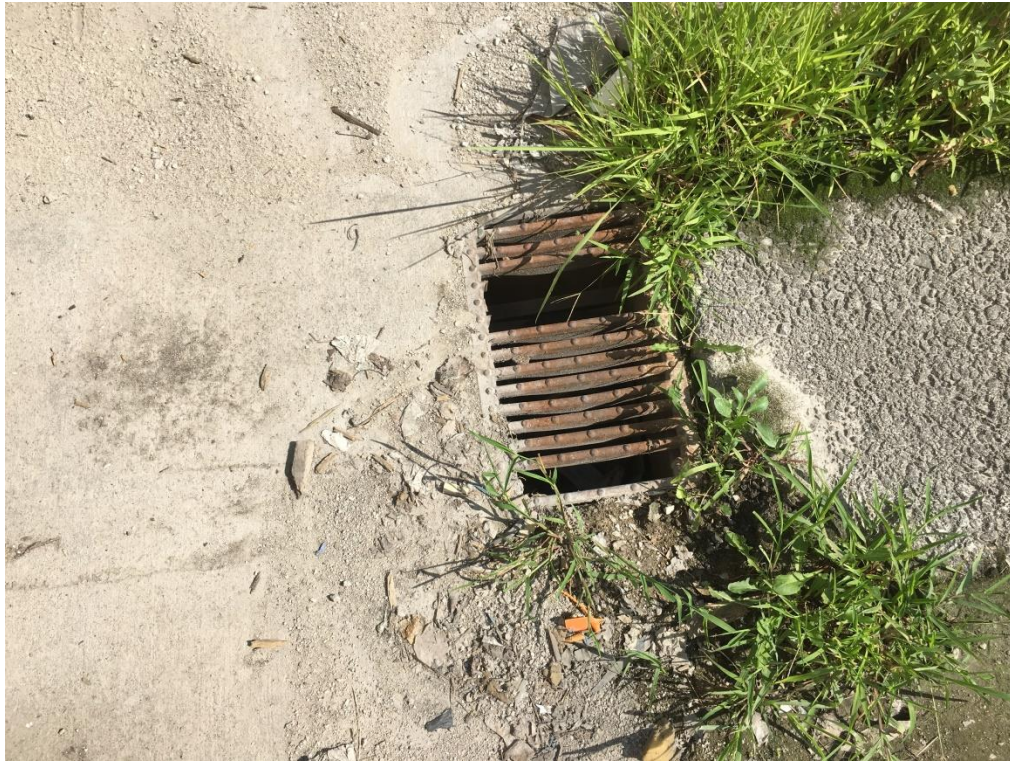
Photograph 28- Location Lot 5, Broken grate, potential tripping hazard.

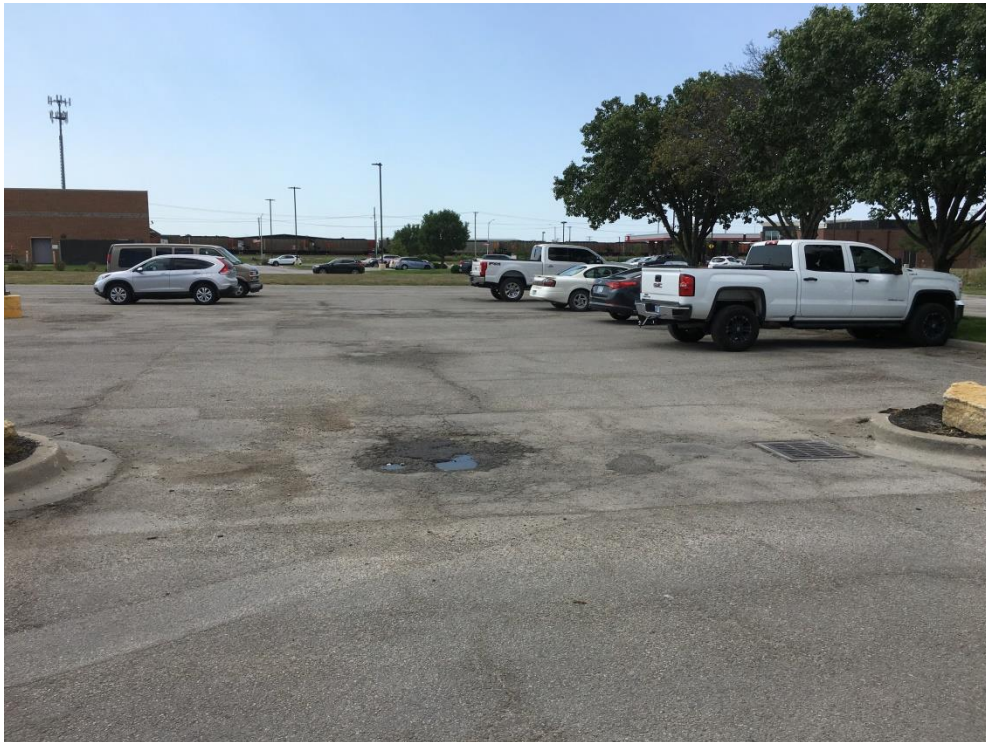
Photograph 29- Location Lot 5- Large pot holes in pavement, potential tripping hazard.

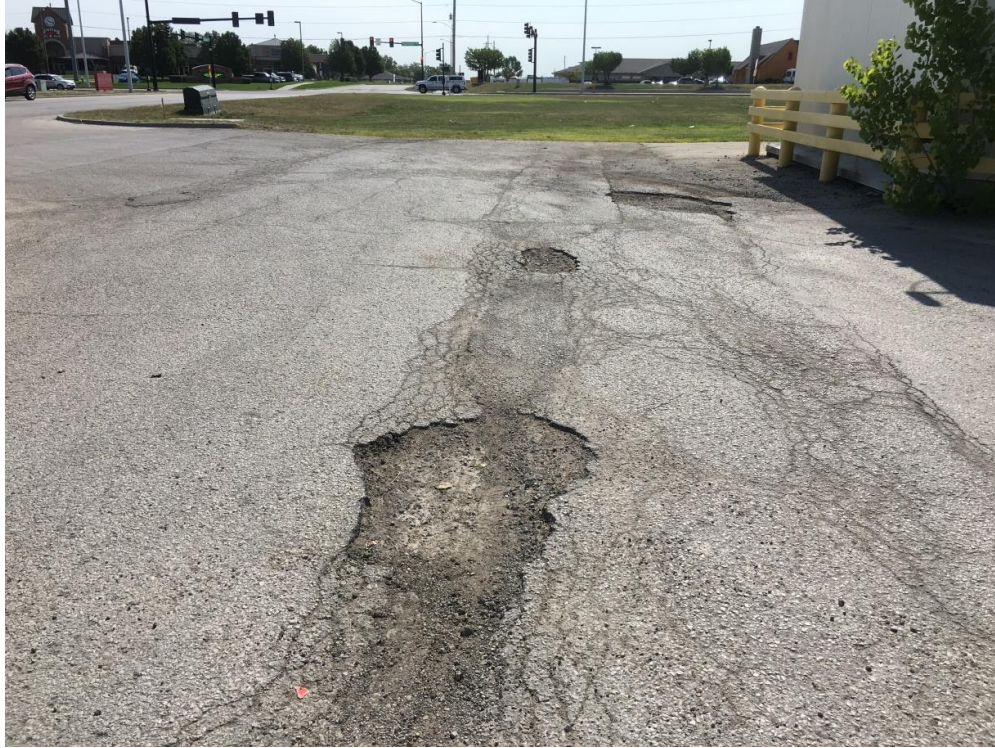
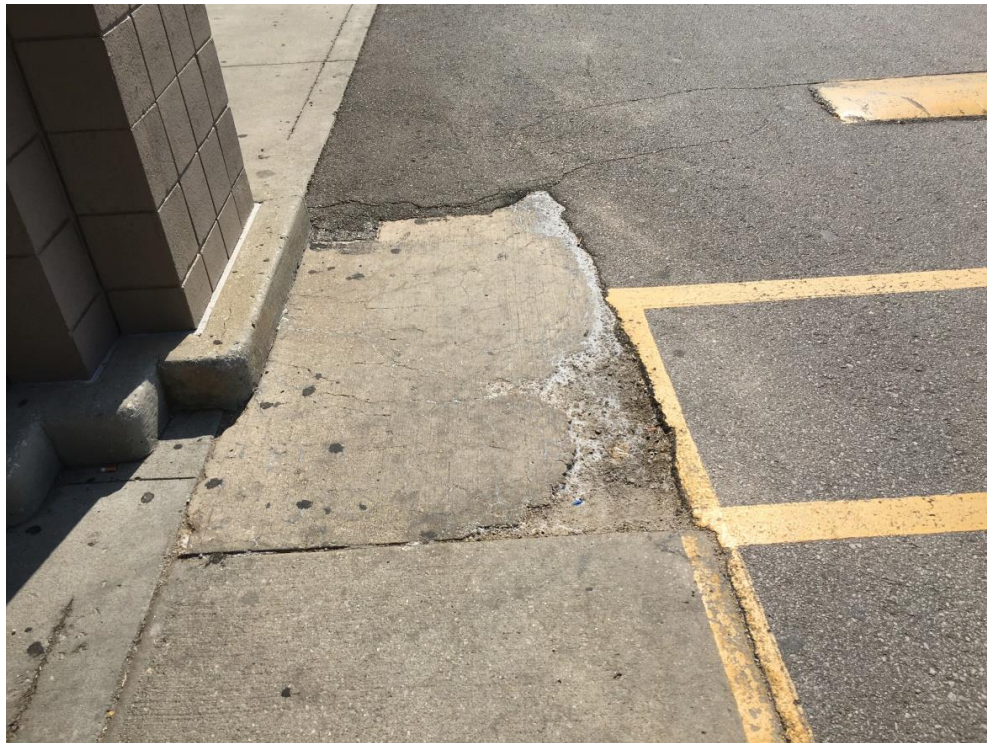
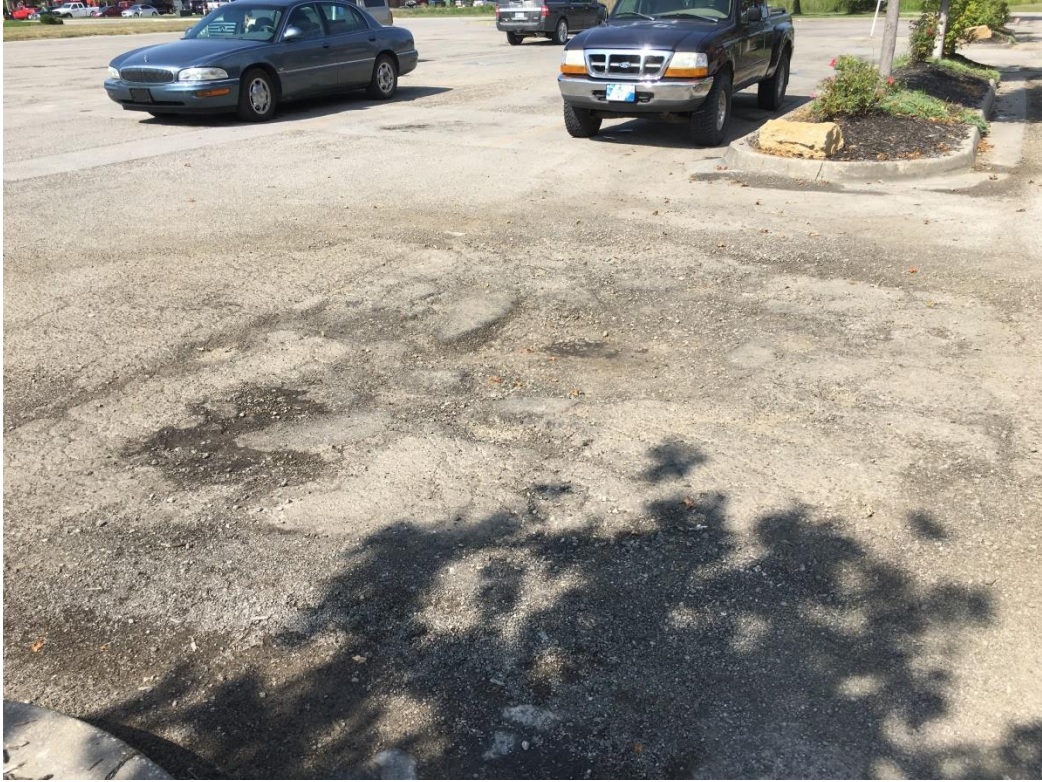
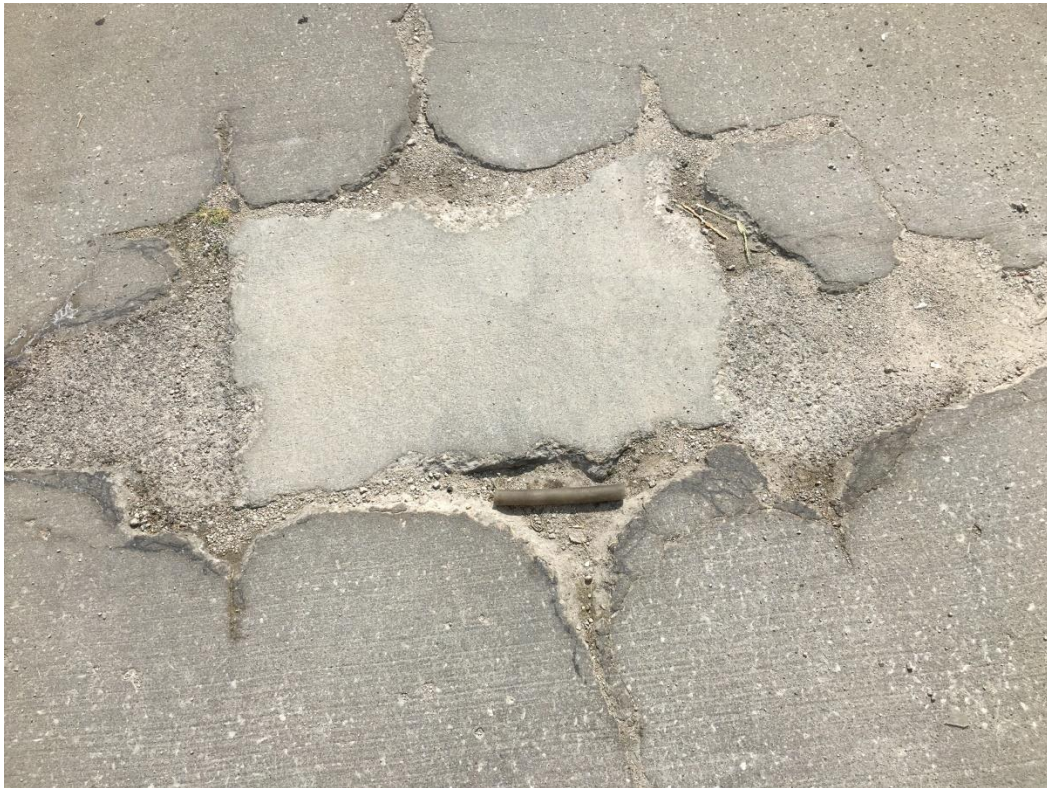
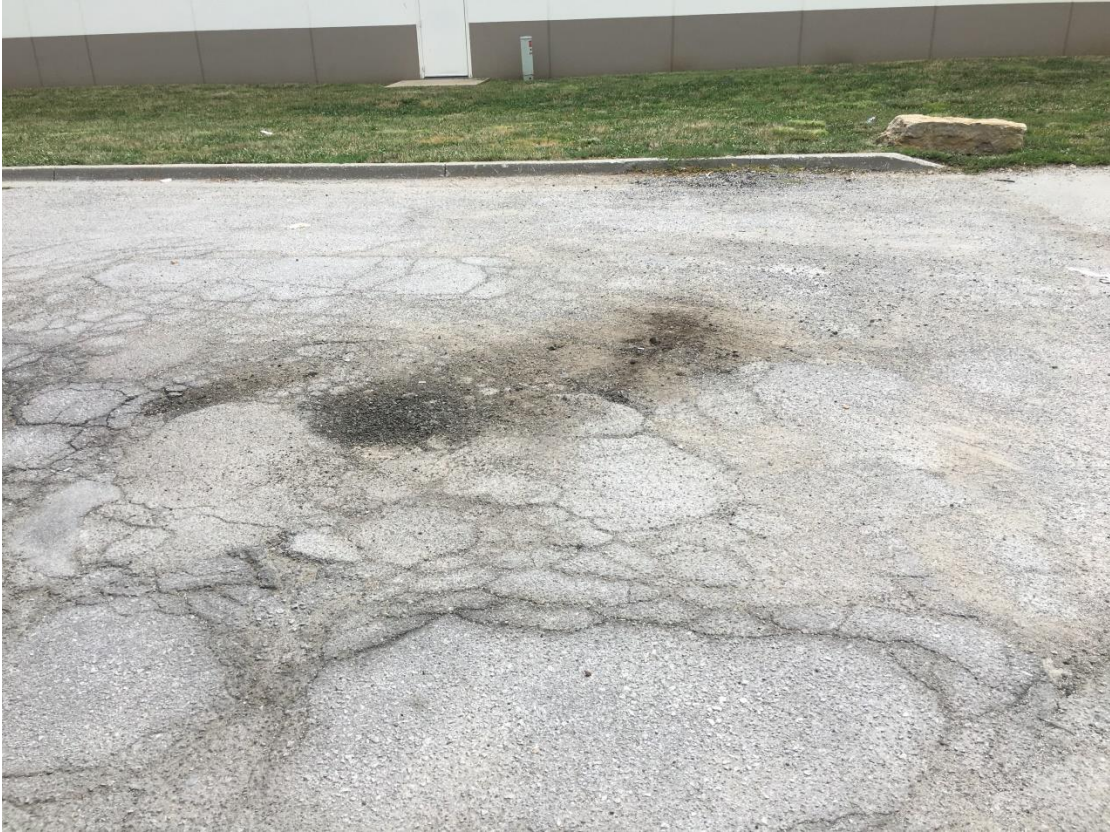
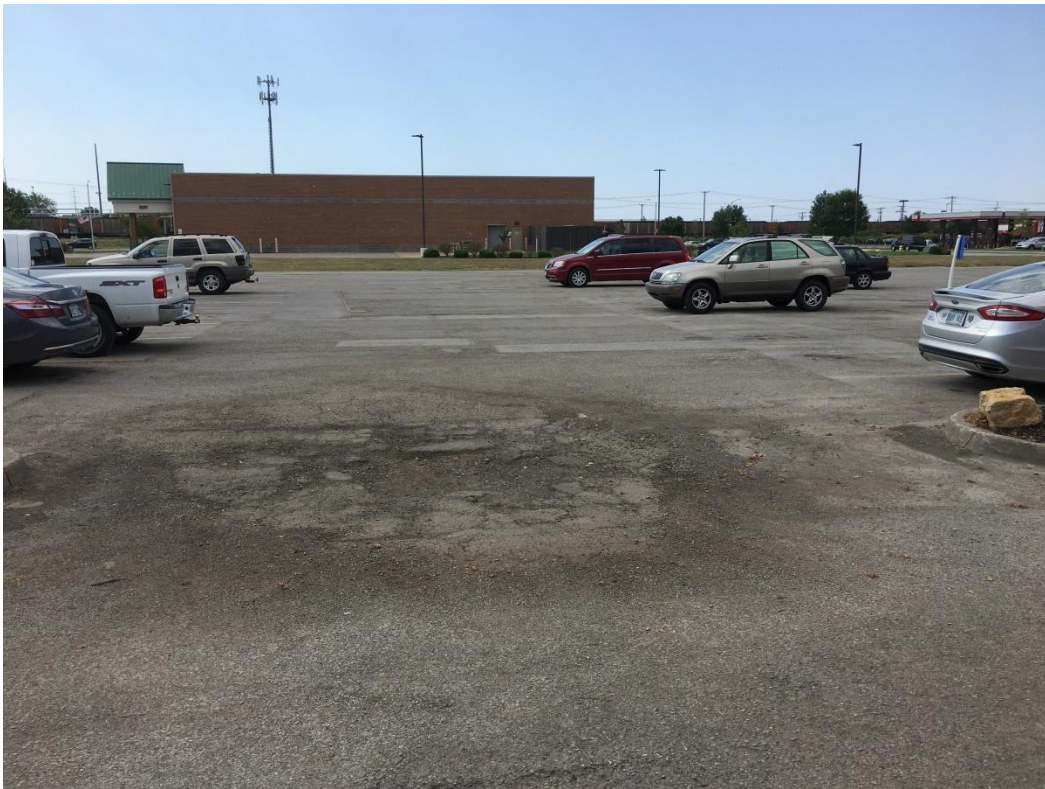
The commercial parking lots are strewn with potholes, deep cracks and scaling. In addition to the structurally unsafe condition of portions of the existing commercial buildings, the surrounding curbs and sidewalks are crumbling. The vacant land on Lot 1 and Lot 2 are overgrown with weeds. Some Items around the exterior of the buildings are unsightly and in a deteriorated state.

Photograph 31- Deterioration of site improvements.
