Qualifications Analysis Main Street Market Place

Gardner, Kansas

August 23, 2018

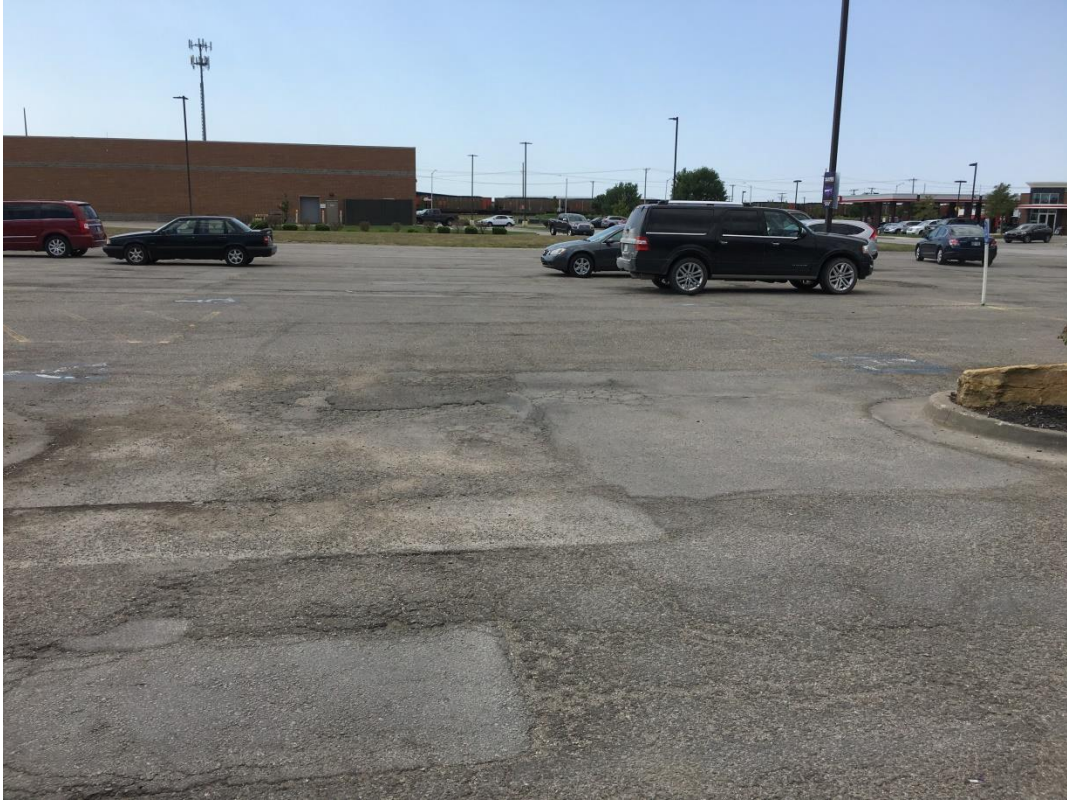
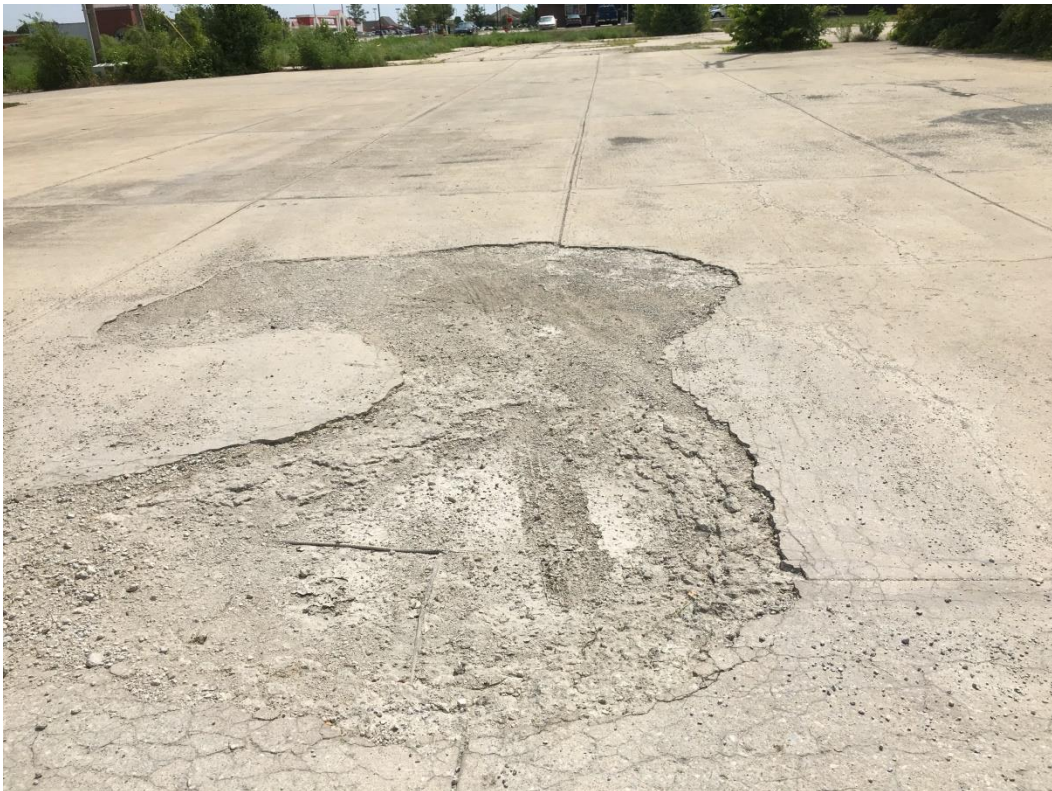
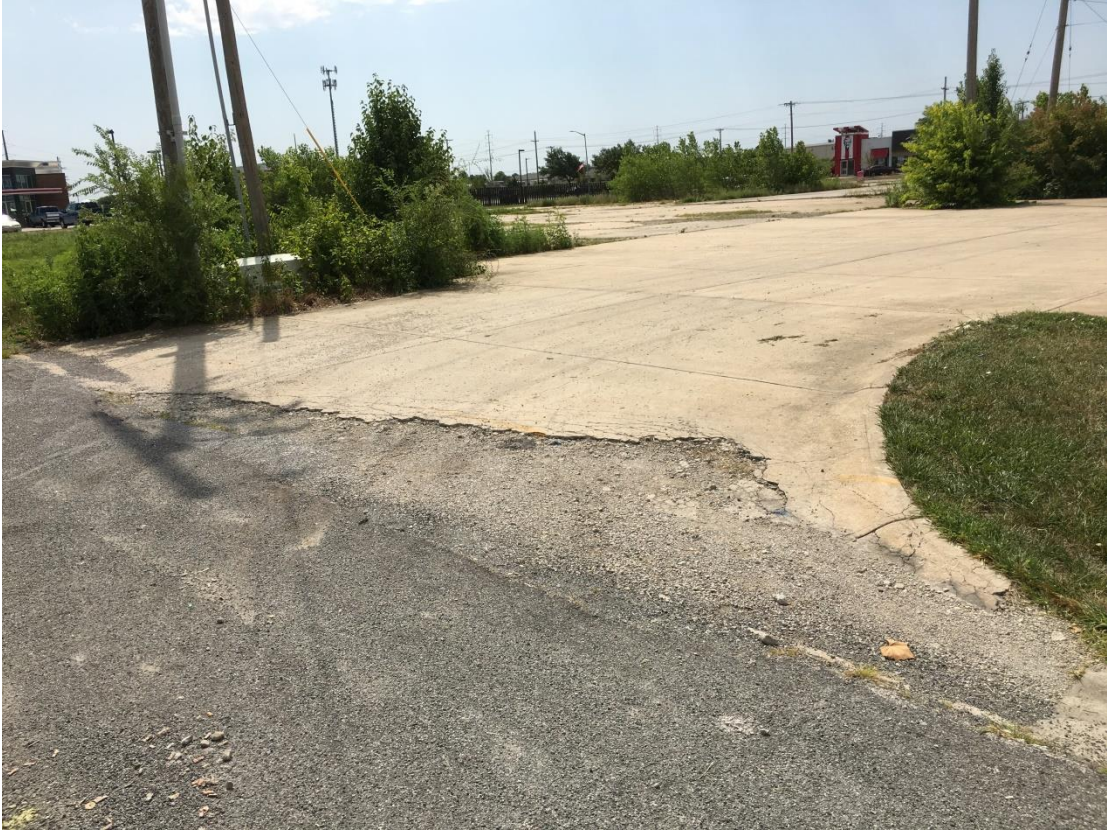
The commercial parking lots are strewn with potholes, deep cracks and scaling. In addition to the structurally unsafe condition of portions of the existing commercial buildings, the surrounding curbs and sidewalks are crumbling. The vacant land on Lot 1 and Lot 2 are overgrown with weeds. Some Items around the exterior of the buildings are unsightly and in a deteriorated state.

Photograph 37- Deterioration of site improvements.

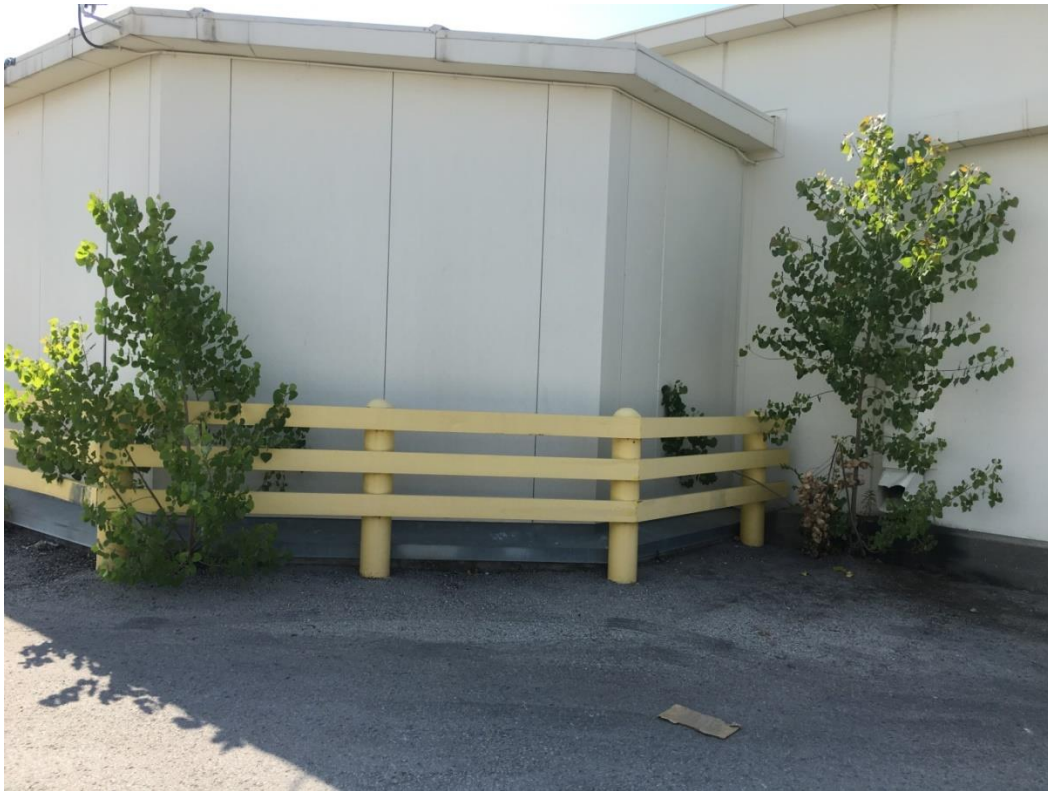
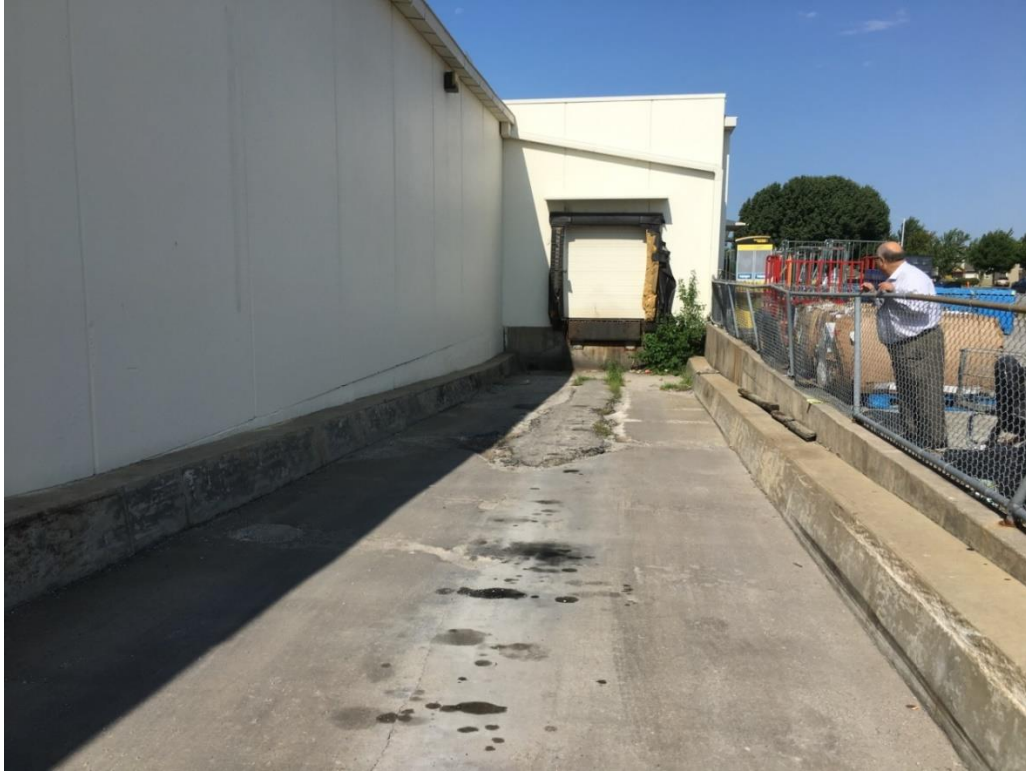
Photograph 40- Location Lot 5- Trees growing at side of building.

Photograph 41- Location Lot 5- Trees growing at side of building.

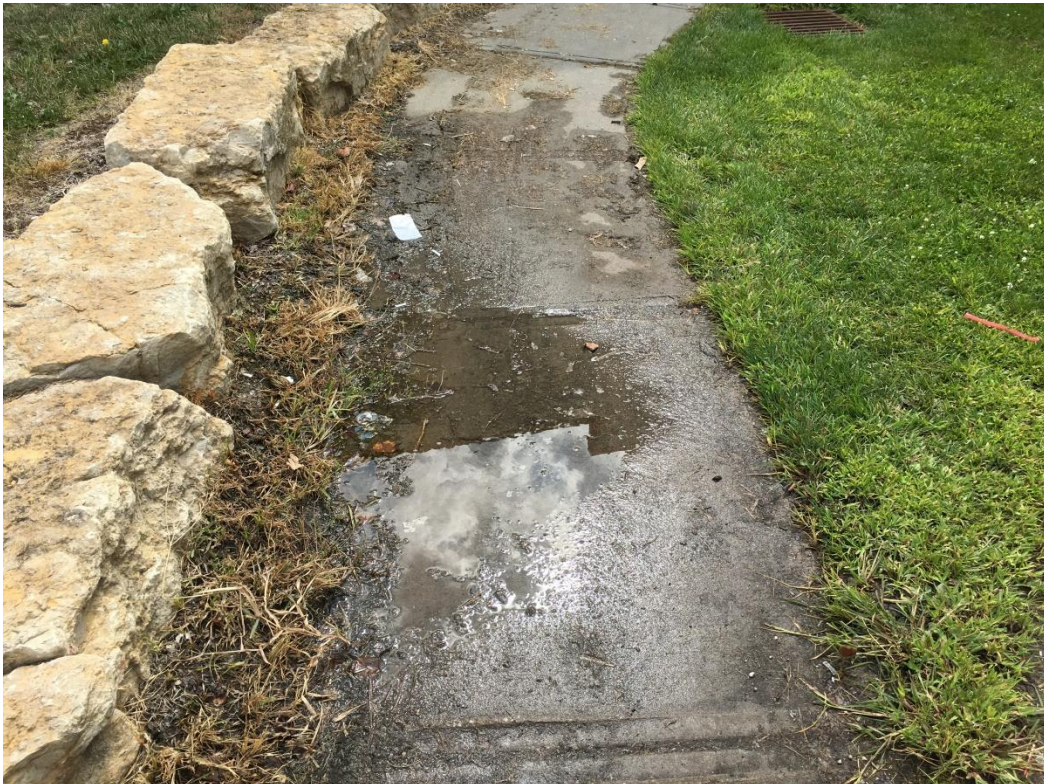
Photograph 42- Standing Water on Lot 3.

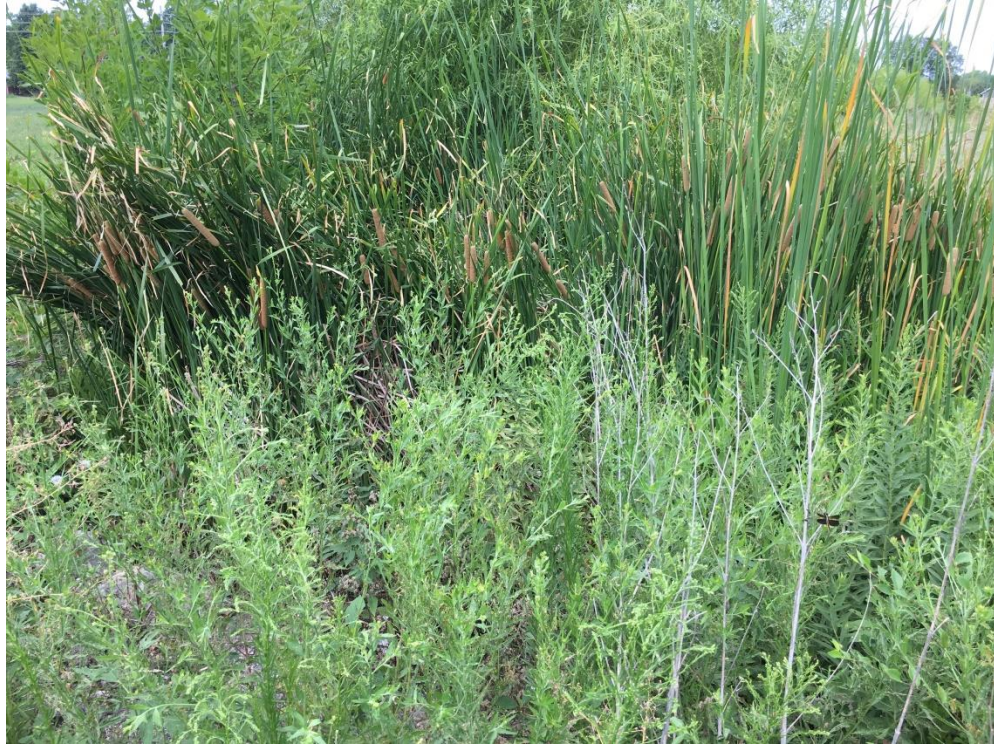
Photograph 43- Standing water in open channel in Lot 1.

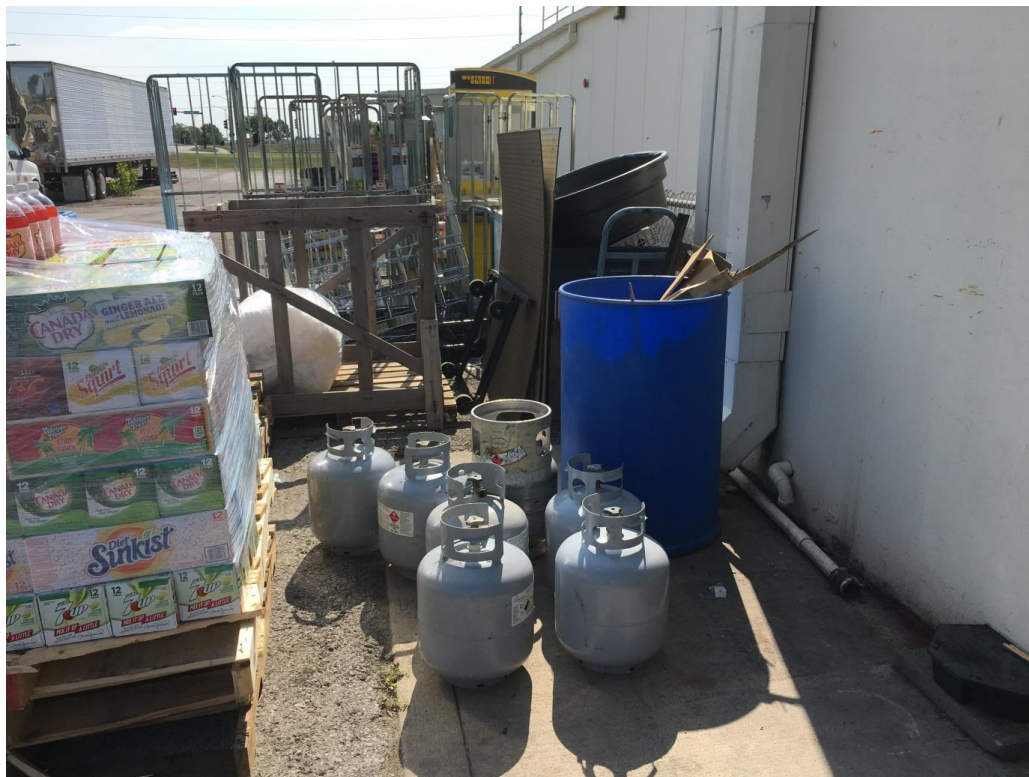
Photograph 44- Open storage of propane containers.
